Daily Report For 2016-05-31

Metal Bank

Sheetpile Repair
Cottman Avenue
Philadelphia, PA (US)
Report number: 3340011G-17
Date: May 31, 2016 01:08 PM

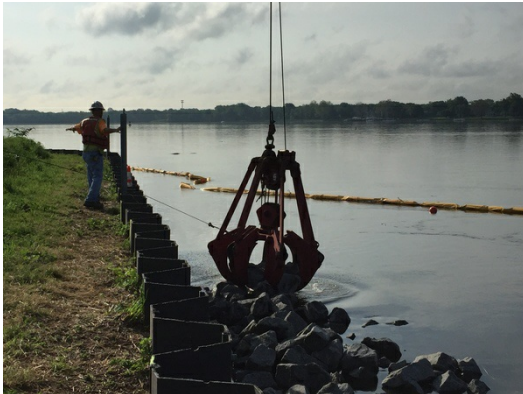
<p>R6 stone placement via crane in Zone 2 (facing NE)</p>

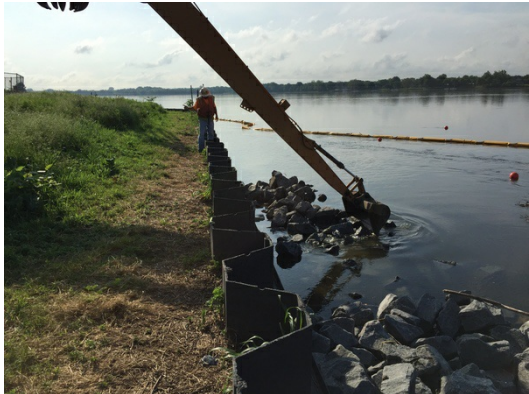
<p>Long-reach excavator ensuring R6 stone placement is up along sheet pile wall (facing NE)</p></div> <div>

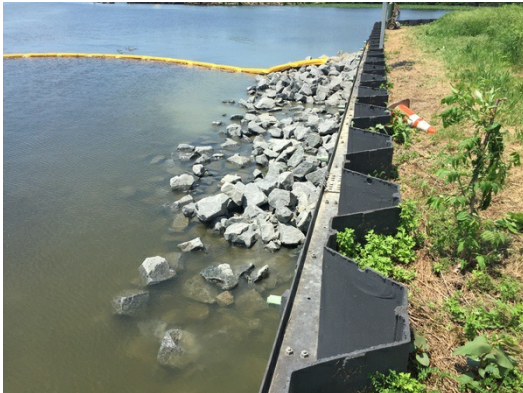
<p>Extent of R6 stone placement, nearing completion in Zone 2 (facing SW)</p></div>

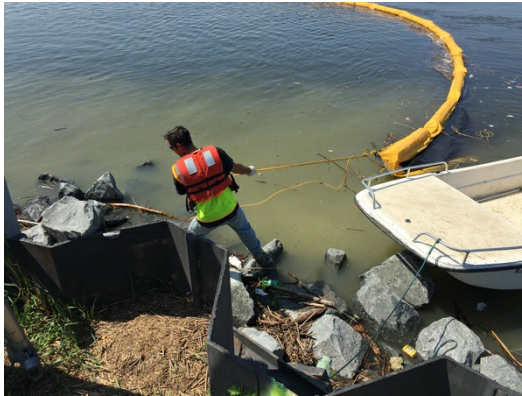
Adjusting turbidity curtain to close gap created as tide receded (facing E)

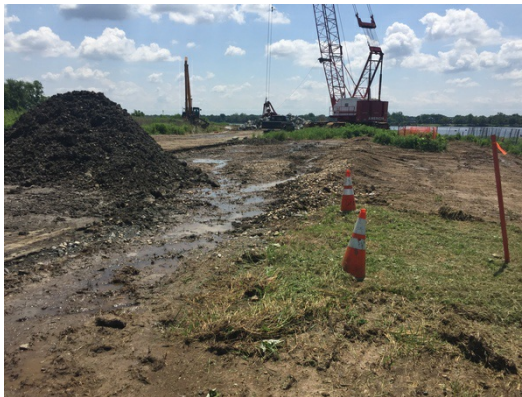
The excavator continued rebuilding the perimeter berm, and stockpiled the crushed stone formerly used for staging the R6 in that area.

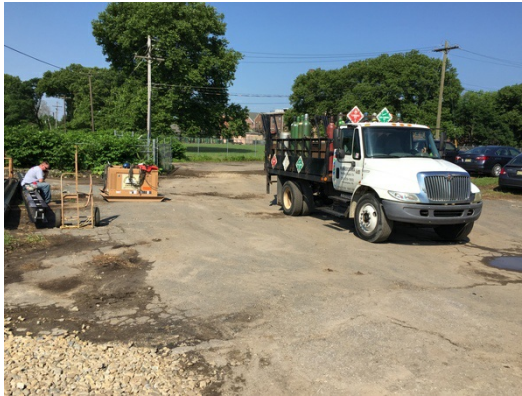
Welding equipment delivery (facing S)

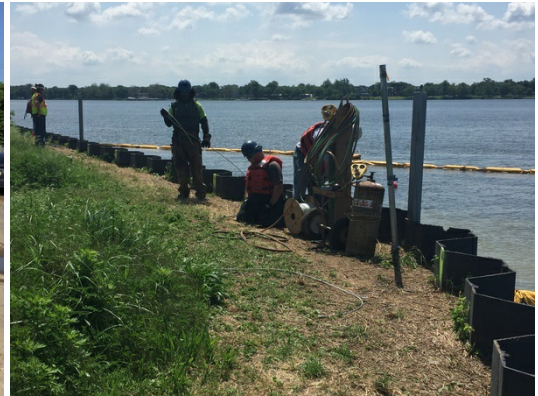
Welders cutting cables for work platform (facing E)

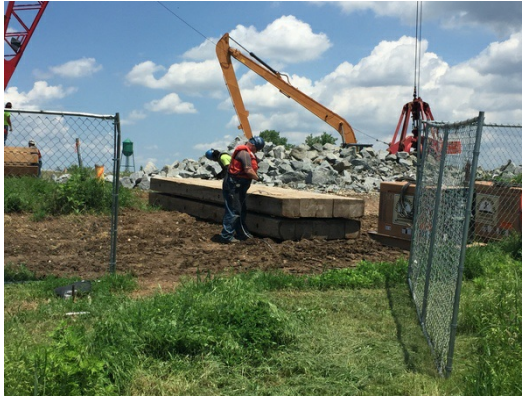
Attaching cables to work platform (facing N)

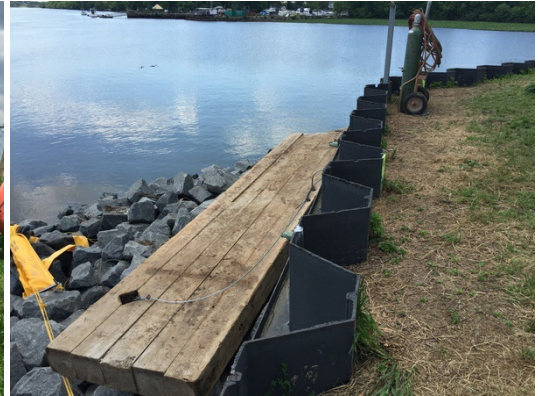
Positioning work platform (facing SW)
